Name of Dam: Fleming Dam

Location: Cumberland County, Commonwealth of Virginia

Inventory Number: VA 04904

PHASE I INSPECTION REPORT

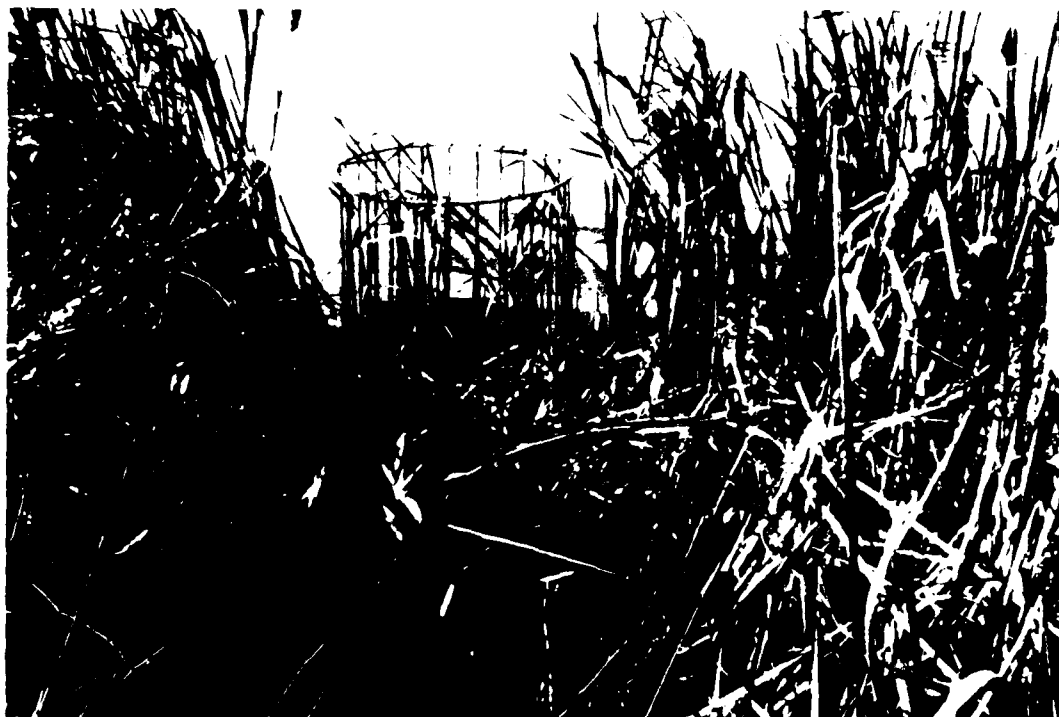
Appurtenant Structures: The intake structure of the principal spillway consists of a vertical 36 inch diameter CMP acting as a riser. This inlet is enclosed in a two foot high cage made of reinforcing rods welded together to form a trash rack. A few inches of leaves and weedy material is plugging the bottom of the trash rack. The outlet conduit is a 24 inch diameter bituminous coated CMP, which is in good condition. The outlet structure consists of the end of the 24 inch conduit protruding directly from the embankment with no visible supporting structure. The immediate outlet area is well riprapped with slate. The outlet channel is generally wide and unobstructed and extends from the outlet structure approximately 50 feet downstream, where it merges with the emergency spillway discharge channel to form the downstream channel. During the field inspection, the flow through the principal spillway was approximately 2 c.f.s.

PHOTO 1. Principal Spillway Inlet Trash Screen

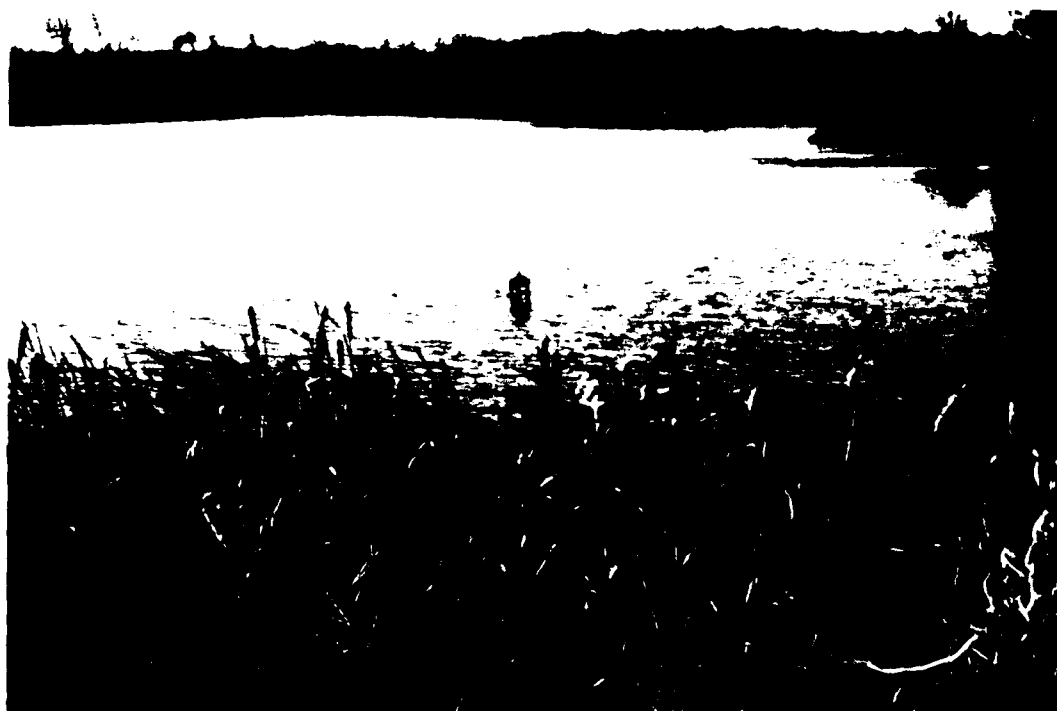
The emergency gate is located approximately 30 feet upstream of the riser. The size of the emergency gate is unknown and the control wheel is missing from the gate stem.

PHOTO 2. Emergency Gate Control

| VISUAL EXAMINATION OF | OBSERVATIONS | REMARKS OR RECOMMENDATIONS |
|---|---|--|
| EMERGENCY GATE | The emergency gate control is located approximately 30 ft. upstream of the riser. The size of the emergency gate is unknown, and the control handle is missing. | The emergency gate control should be checked, repaired if necessary and maintained in an operable condition. The control handle should be either permanently installed or stored in an easily accessible location. |

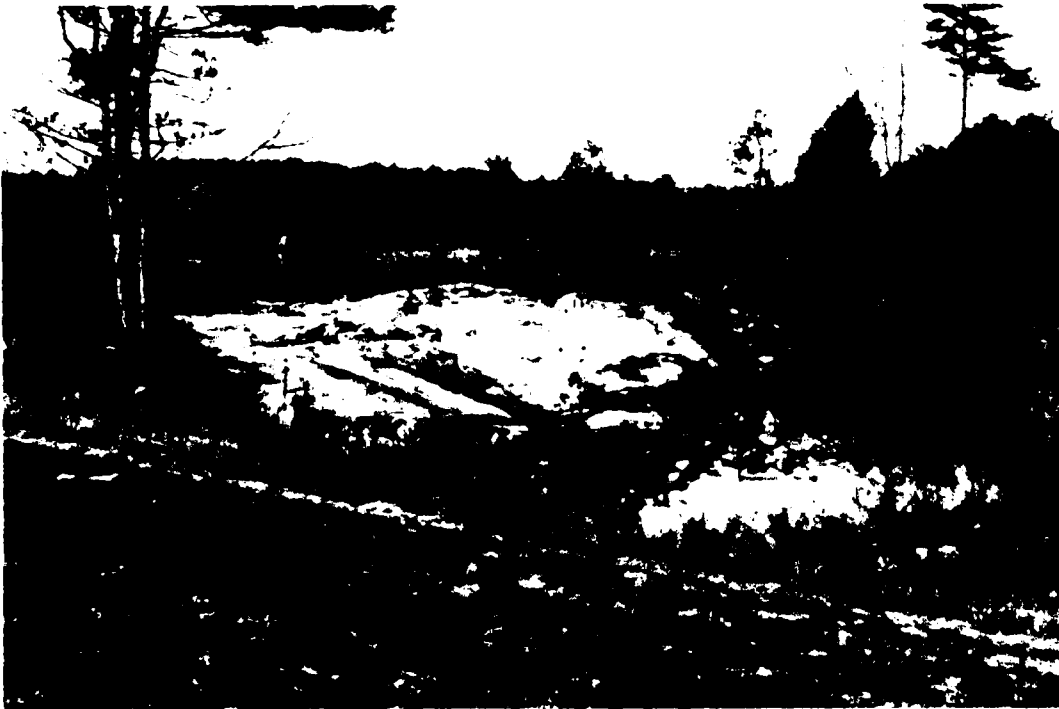
Several wet areas were noticed below the dam, but these are attributed to poor drainage conditions of areas below the dam and not to seepage through the embankment. A deep gully was eroded in the bedrock on the right side of the emergency spillway discharge channel (away from the embankment) about 100 feet downstream of the control section. Neither of these items poses a threat to the stability of the dam.

**PHOTO 4. Emergency Spillway (Looking Upstream), Bedrock
Control Section**

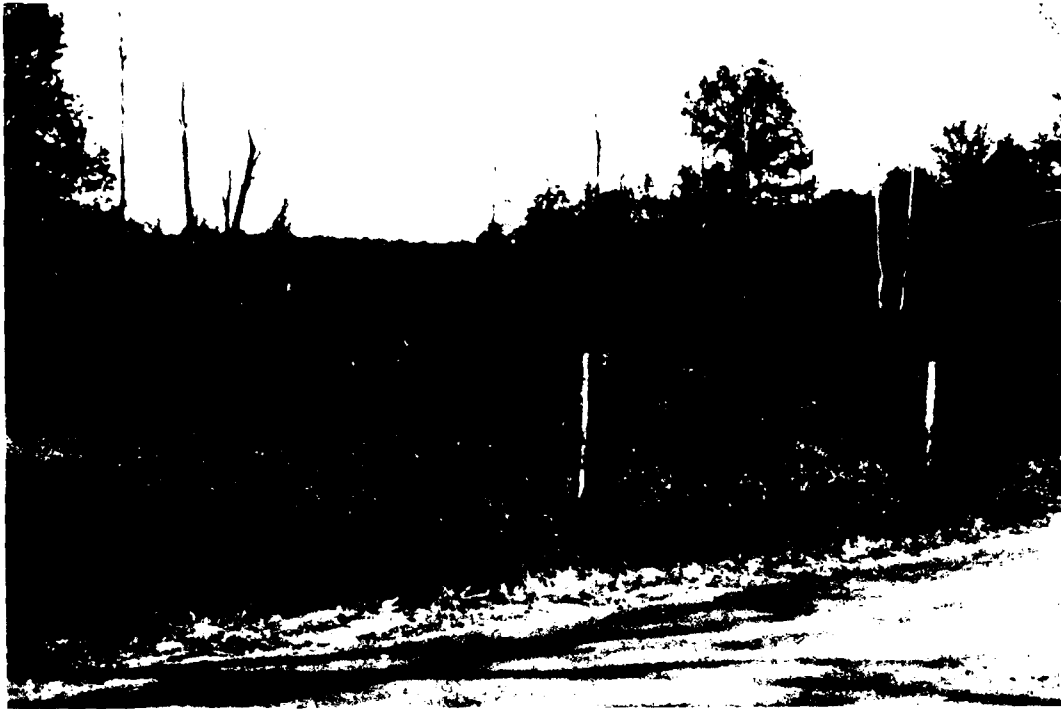
considerably steeper than recommended; however, the existing slope shows no signs of instability, even though it is quite irregular and penetrated by numerous animal burrows. A stability check is not required.

PHOTO 5. Downstream Embankment, Flatter Segment Above Principal Spillway Outlet

- 1) Remove the large trees and their root systems from the downstream embankment. The slope should then be regraded with compacted fill.
- 2) Clear the brush and small trees (less than three inches in diameter) from the downstream embankment.
- 3) Backfill the animal burrows and establish a grass cover over the entire embankment.
- 4) Repair the erosion at the junction of the downstream embankment and the left abutment.
- 5) Clean the trash rack at the inlet to the principal spillway.
- 6) Repair the erosion rills in the emergency spillway approach channel.
- 7) Install a staff gage to monitor reservoir levels above normal pool.
